NEW HORTICULTURAL FARM DAM

HOWARD COUNTY, MISSOURI

MO. 10790

**PHASE 1 INSPECTION REPORT
NATIONAL DAM SAFETY PROGRAM**

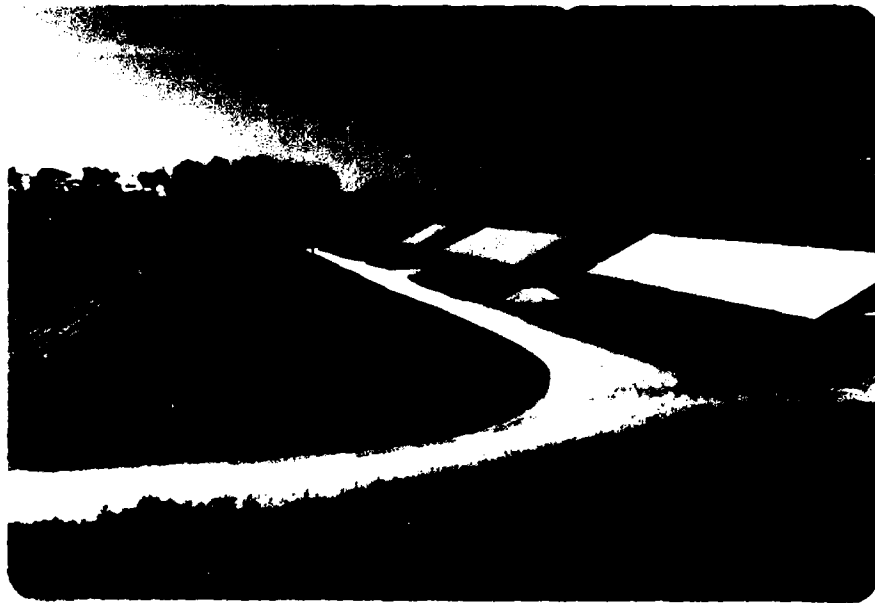
PHOTO NO. 6 - LOOKING DOWNSTREAM FROM STA. 2 + 00

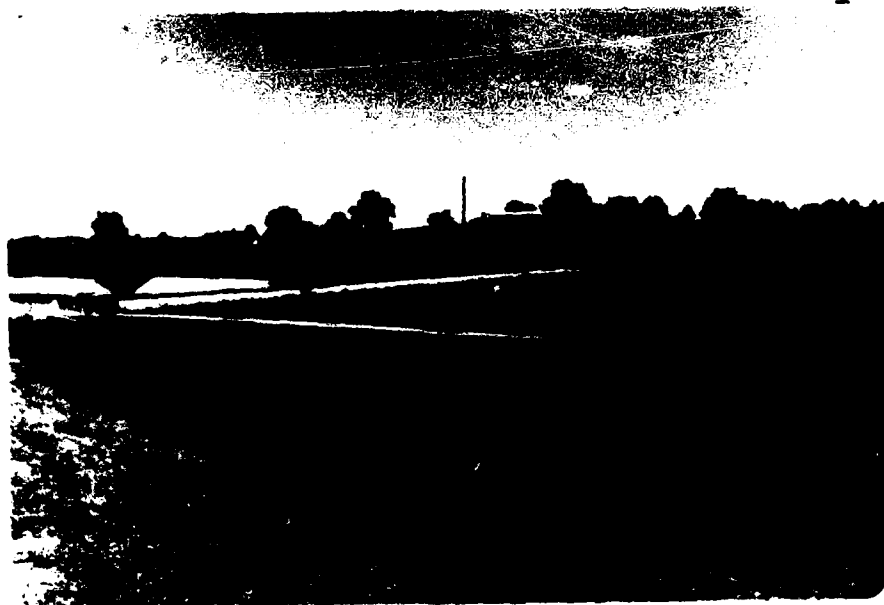
PHOTO NO. 18 - OVERVIEW FROM HIGH ON LEFT ABUTMENT
